Pole Base Weld Toe Cracking

Brian Reese, PE, CWI
Reese Tower Services

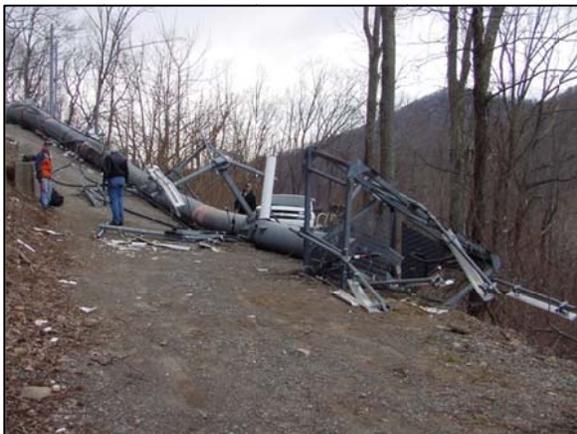
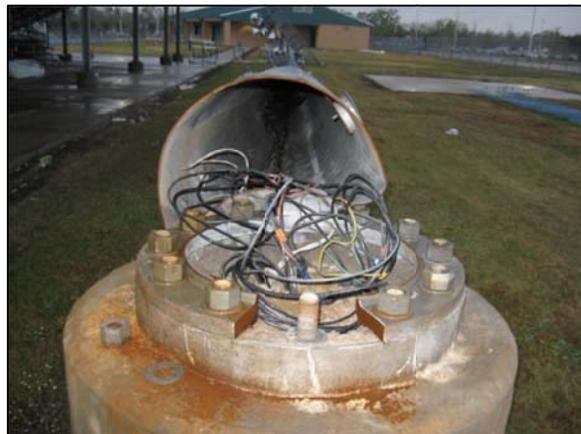
Pole collapses, while traditionally a very infrequent occurrence, have made news in recent years due to failures in both the communication and sports lighting industries. With their proximity to areas where people live, work and gather, there is a significant potential for loss of property damage, injury and possibly even loss of life.

Almost all recent pole failures have possessed one similar characteristic: toe cracks in the pole shaft wall immediately above the base plate weld that propagate over time causing this connection to fail and the pole to collapse. In recent years, many owners have implemented inspection programs to identify base defects that can be detrimental to the long-term performance of their structures. Toe cracks have been routinely identified during these preventative inspections.

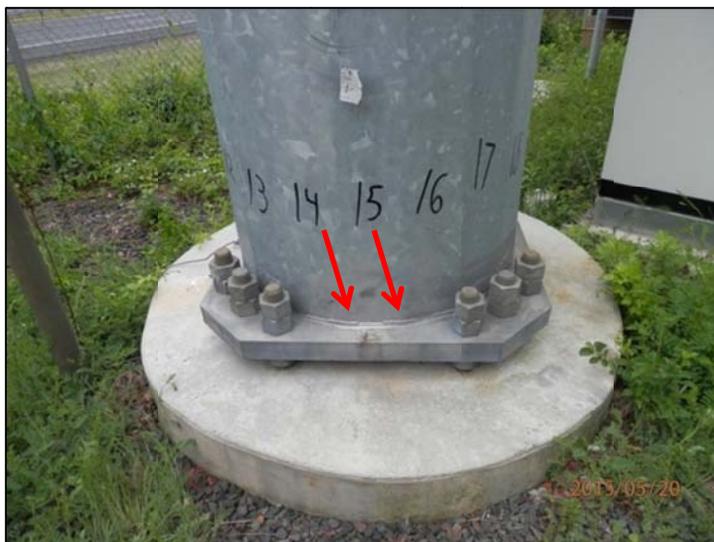
OEM Toe Crack Repairs Visible in the Field

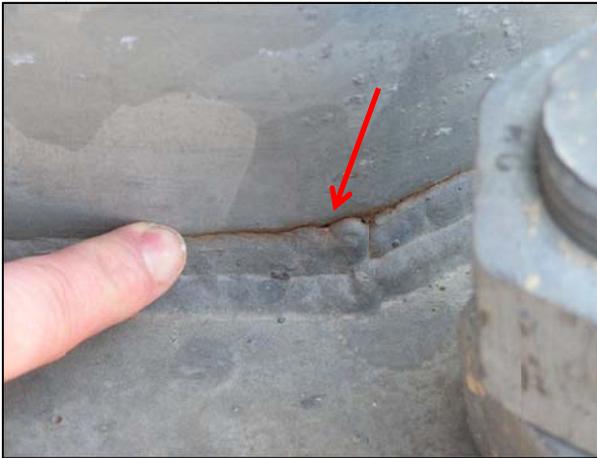
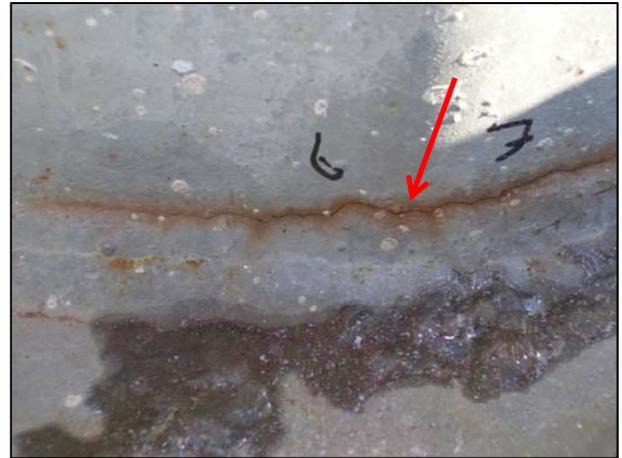
Toe Cracks at Upper Toe of Weld in Pole Shaft at Bend Line (Visible Rust)

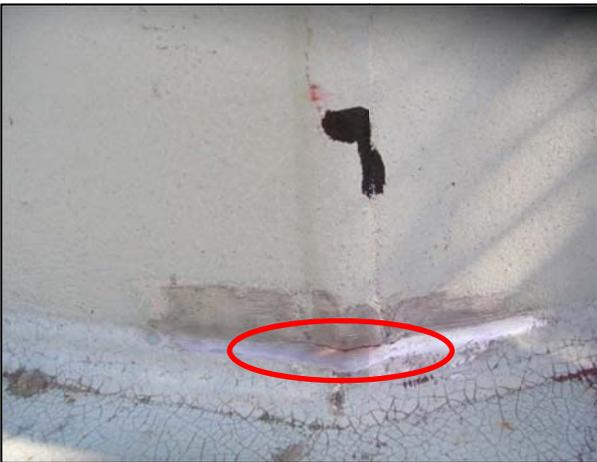
Minor Toe Crack Visible via MT Powder after Light Grinding

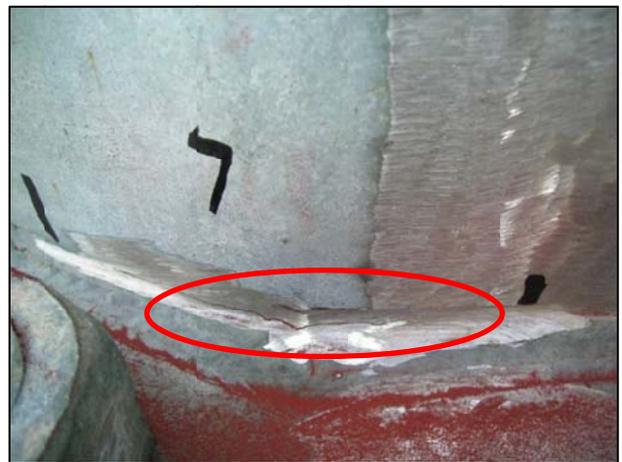
Toe Crack Visible via MT Powder after Grinding

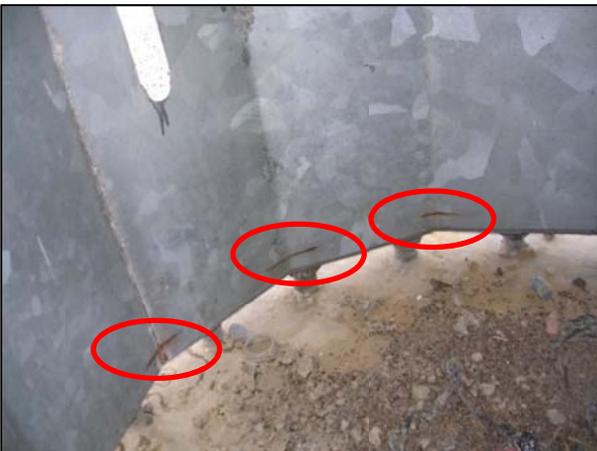
Socket Style Base Connection Toe Cracking Viewed From the Inside of the Pole (Visible Rust)

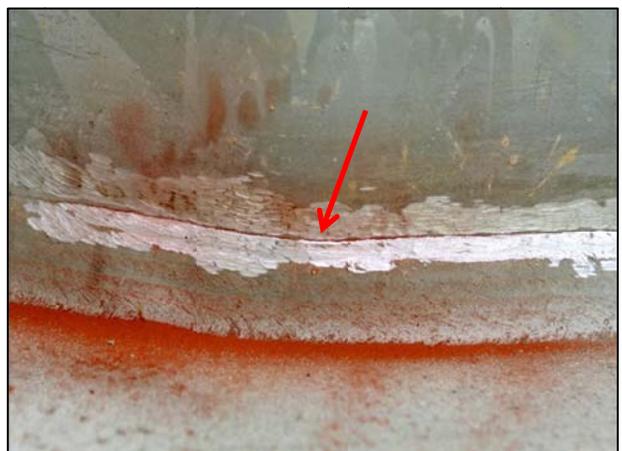
MT Powder at Upper Toe Crack
